Manhole Inspection Summary

Manhole # S53KK_003MH

Location Address: **Edison Highway**

Cross Street: **Lanvale Street**

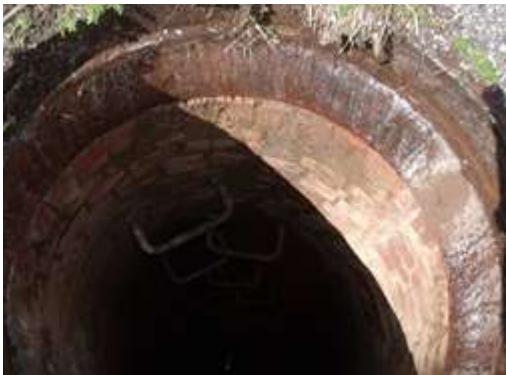
Defect 1

☒ **Leaks**

Frame Leaks

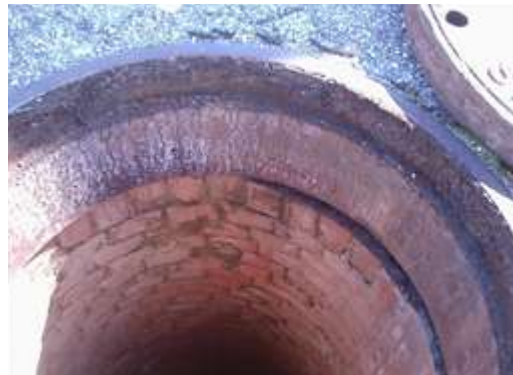
Defect 2

Infiltration: ☐ None ☒ **Joint** ☐ Cracks ☐ Mortar ☐ Roots ☐ Wall

Adjustment Joint

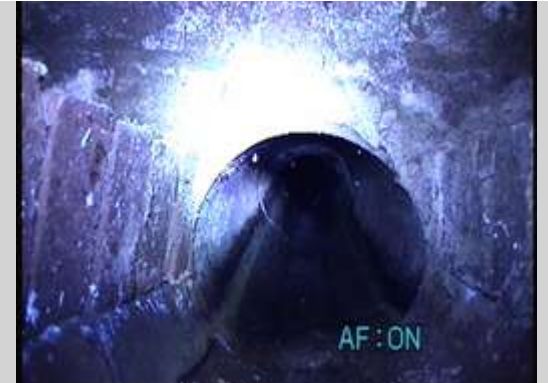
12 O'Clock Outflow

8 in. Circular Gravity Sewer
Pipe Out @ 12 O'Clock

Pipe Height: **8.4** (in.) Rod and Bar (Angled)
Pipe Material: **Clay** ☐ Pipe Lined
Invert Depth: **16.00** (ft.) Flow Characteristics: **Slow**
Deposits: ☒ None ☐ Mud ☐ Sludge ☐ Debris ☐ Grease
Silt Depth: (in.) Deposits Extent:
Infiltration: **None** Pipe Seal Cond: **Sound**

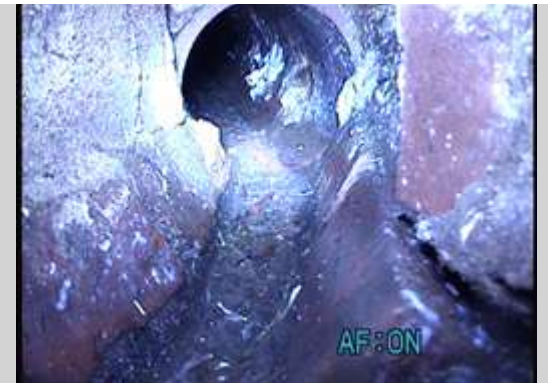
4 O'Clock Inflow

6 in. Circular Gravity Sewer
Pipe In @ 4 O'Clock

Pipe Height: **6** (in.) Rod and Bar (Angled)
Pipe Material: **Clay** ☐ Pipe Lined
Invert Depth: **15.40** (ft.) Flow Characteristics: **Slow**
Deposits: ☒ None ☐ Mud ☐ Sludge ☐ Debris ☐ Grease
Silt Depth: (in.) Deposits Extent:
Infiltration: **None** Pipe Seal Cond: **Sound**

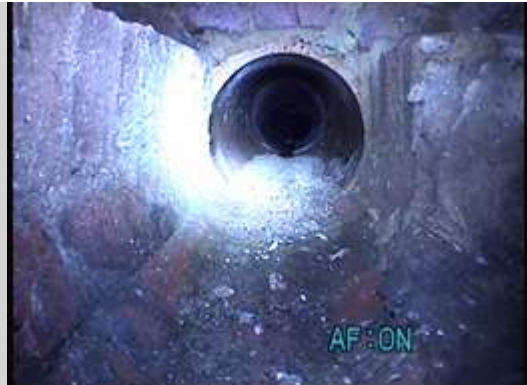
6 O'Clock Inflow

Pipe Height: **8.4** (in.) Rod and Bar (Angled)

Infiltration: **None** Pipe Seal Cond: **Sound**

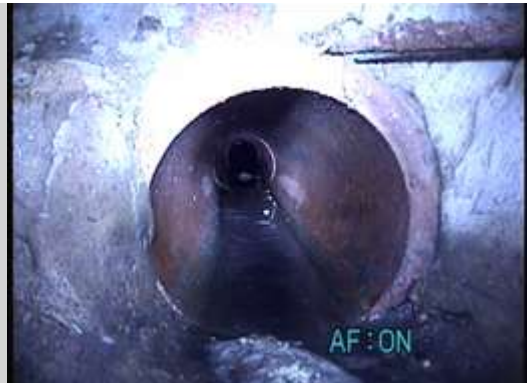
7 O'Clock Inflow

Pipe Height: **8.4** (in.) Rod and Bar (Angled)

Infiltration: **None** Pipe Seal Cond: **Sound**
